IZSUŠEVANJE IN MERITVE VLAGE V STANOVNJSKO POSLOVNIH OBJEKTIH

KOŽAR D.O.O.

TERMORIZIJSKI POSNETKI

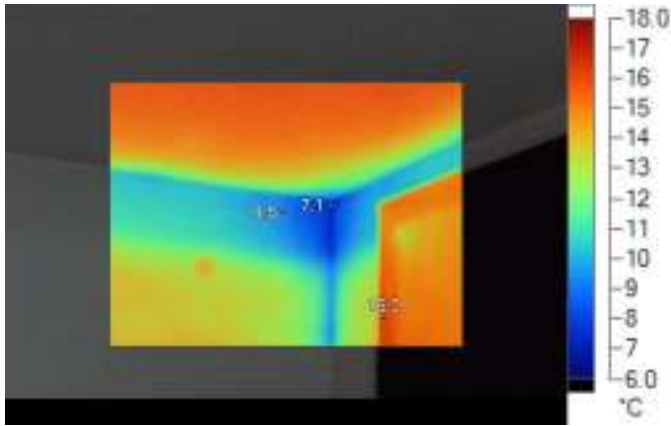
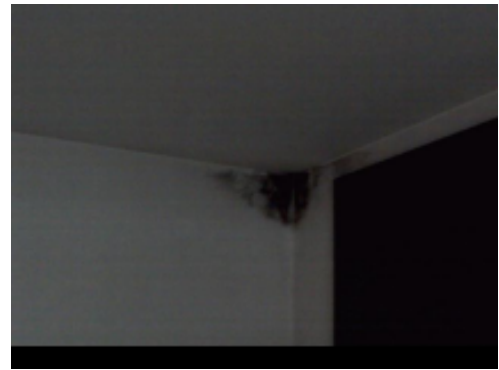
IR000323.IS2
2/2/2011 8:41:16 AM

Background temperature	22.0°C
Average Temperature	13.2°C
Image Range	7.1°C to 16.2°C
Image Time	2/2/2011 8:41:16 AM

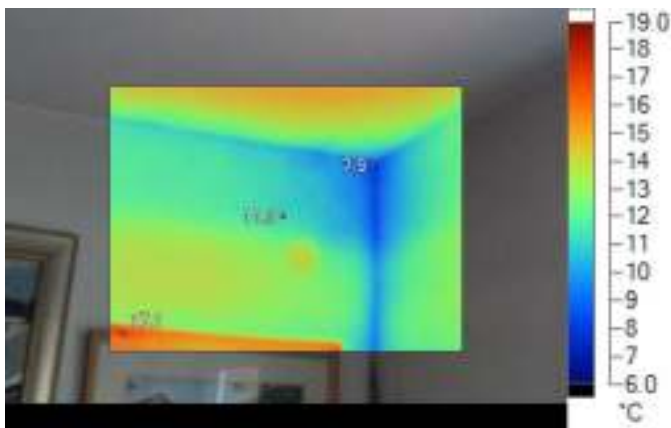
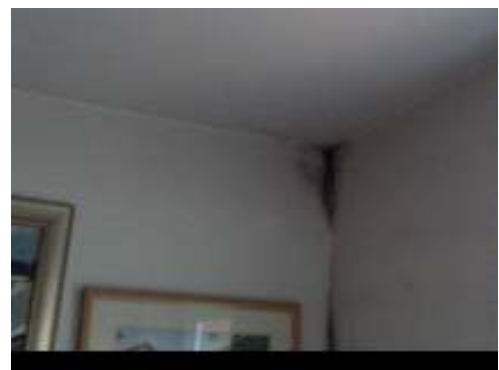
IR000324.IS2
2/2/2011 8:41:35 AM

Background temperature	22.0°C
Average Temperature	12.5°C
Image Range	7.9°C to 17.1°C
Image Time	2/2/2011 8:41:35 AM

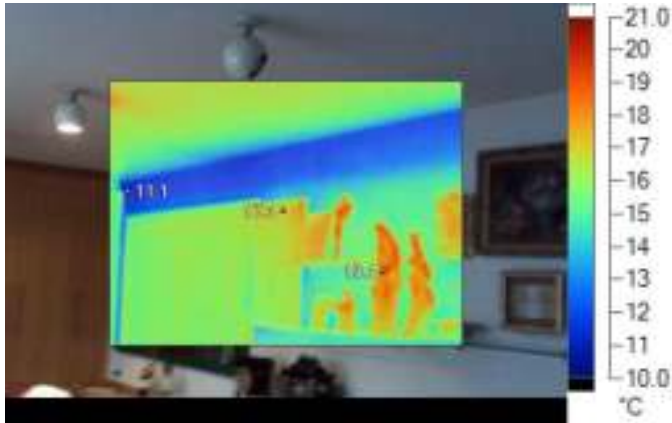
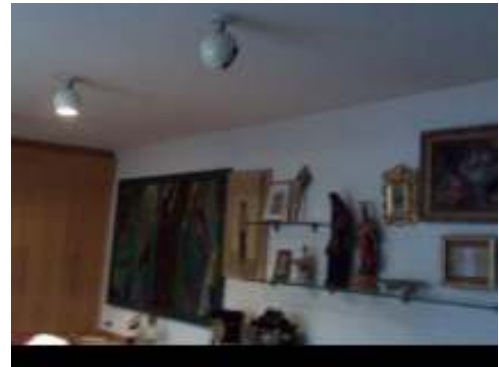
IR000325.IS2

Background temperature	22.0°C
Average Temperature	15.2°C
Image Range	11.1°C to 19.1°C
Image Time	2/2/2011 8:41:54 AM

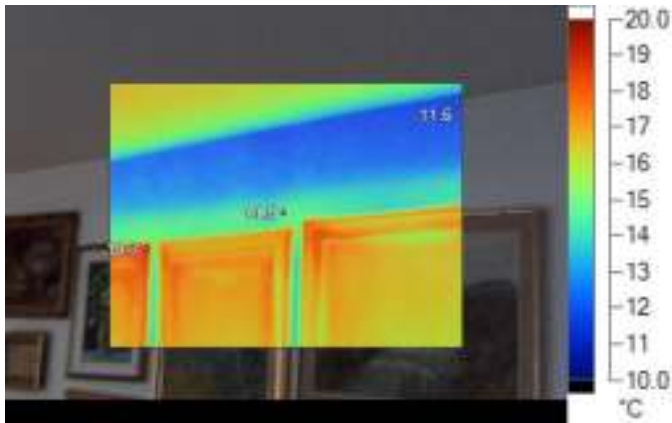
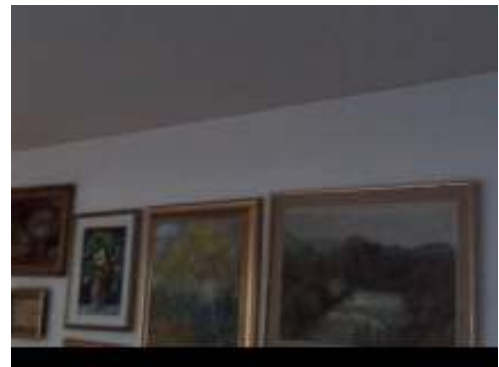
IR000326.IS2

Background temperature	22.0°C
Average Temperature	15.1°C
Image Range	11.6°C to 18.7°C
Image Time	2/2/2011 8:42:11 AM

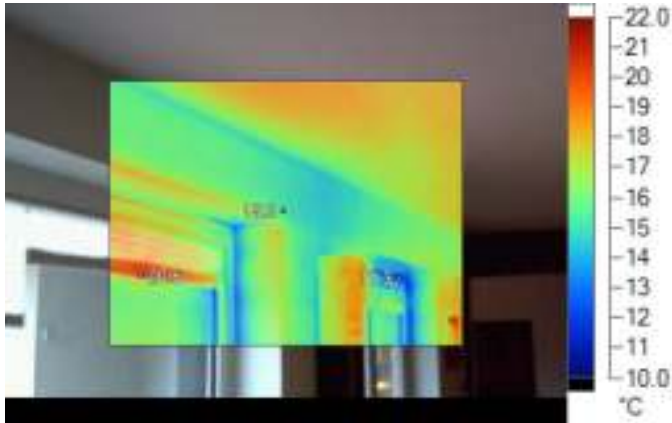
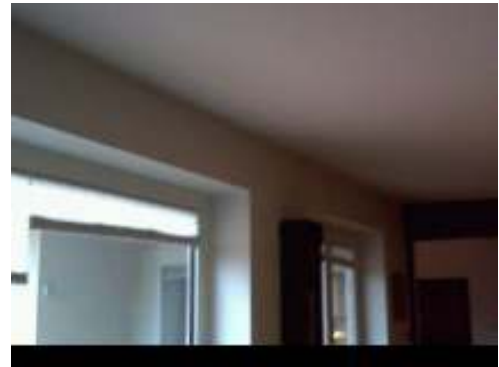
IR000327.IS2

Background temperature	22.0°C
Average Temperature	16.5°C
Image Range	11.3°C to 20.6°C
Image Time	2/2/2011 8:42:37 AM

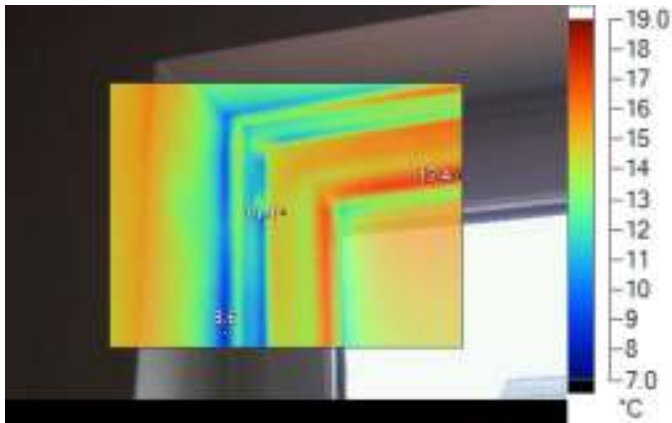
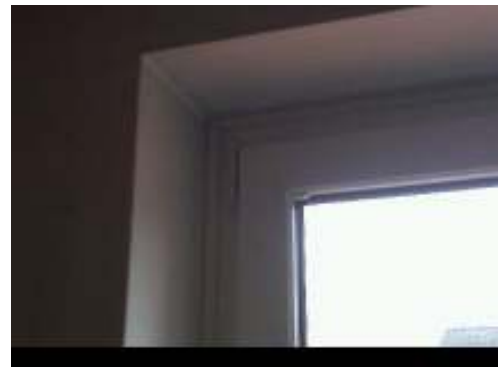
IR000328.IS2

Background temperature	22.0°C
Average Temperature	14.0°C
Image Range	8.6°C to 17.4°C
Image Time	2/2/2011 8:43:28 AM

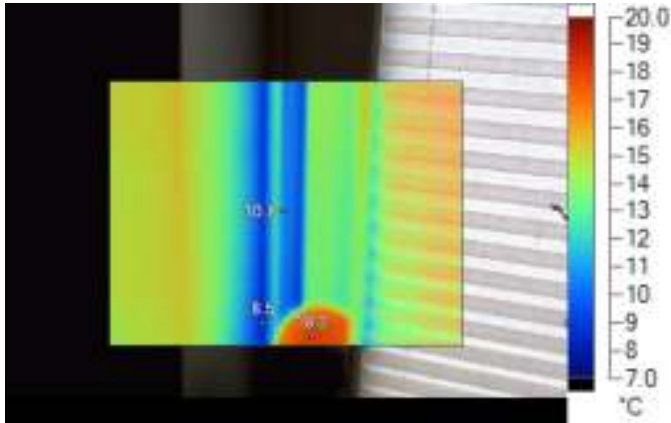
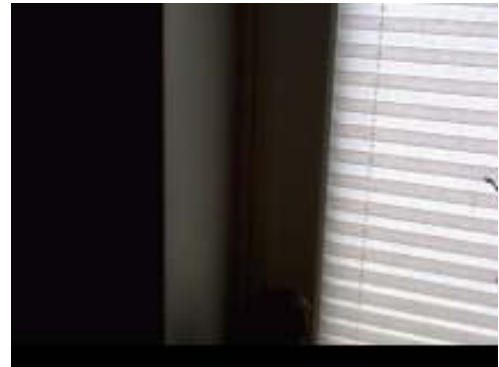
IR000329.IS2

Background temperature	22.0°C
Average Temperature	13.9°C
Image Range	8.5°C to 18.2°C
Image Time	2/2/2011 8:43:40 AM

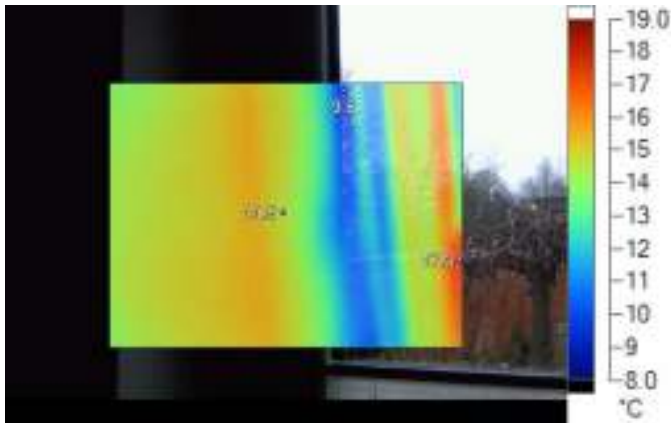
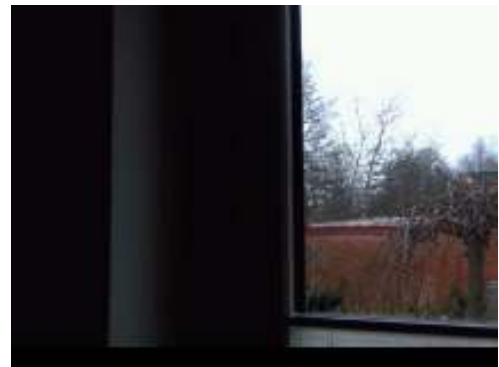
IR000330.IS2

Background temperature	22.0°C
Average Temperature	14.1°C
Image Range	9.8°C to 17.3°C
Image Time	2/2/2011 8:44:13 AM

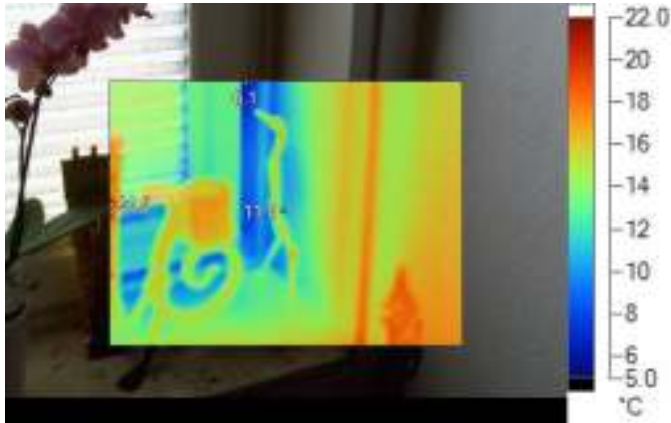
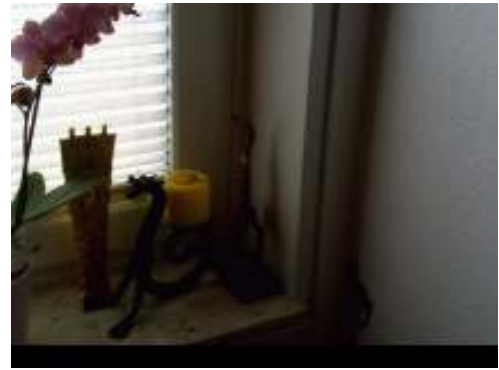
IR000331.IS2

Background temperature	22.0°C
Average Temperature	14.3°C
Image Range	6.1°C to 20.5°C
Image Time	2/2/2011 8:44:39 AM

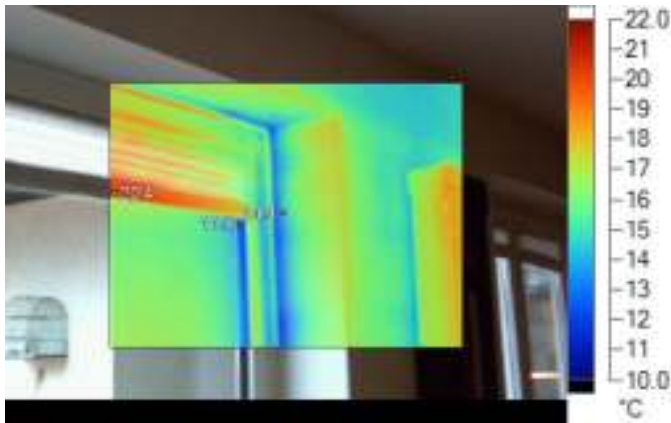
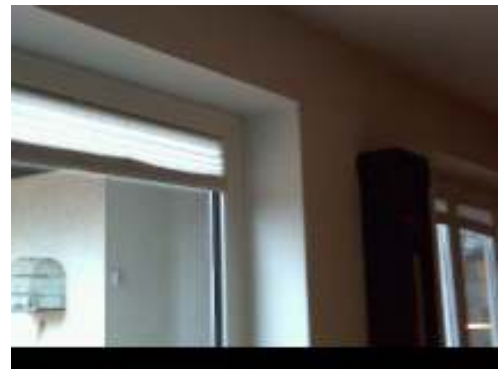
IR000332.IS2

Background temperature	22.0°C
Average Temperature	16.1°C
Image Range	11.8°C to 20.4°C
Image Time	2/2/2011 8:45:00 AM

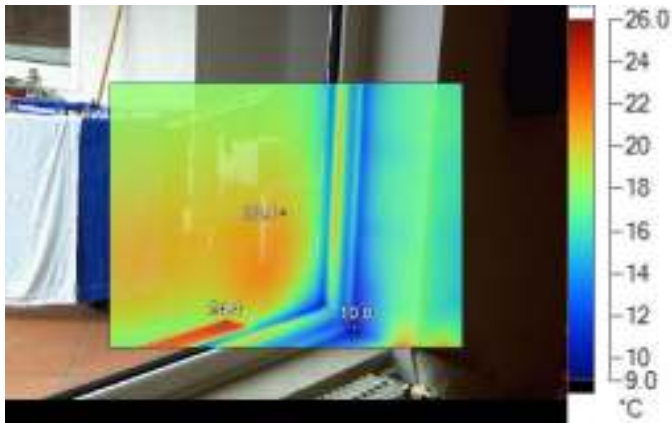
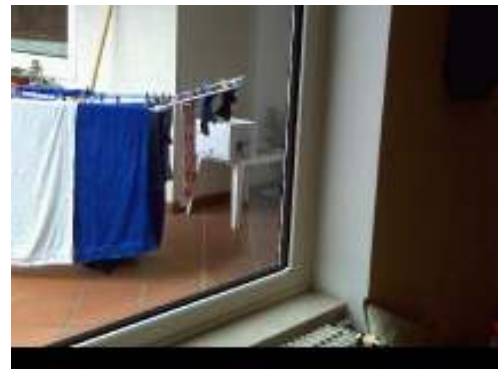
IR000333.IS2

Background temperature	22.0°C
Average Temperature	17.9°C
Image Range	10.0°C to 24.4°C
Image Time	2/2/2011 8:45:13 AM

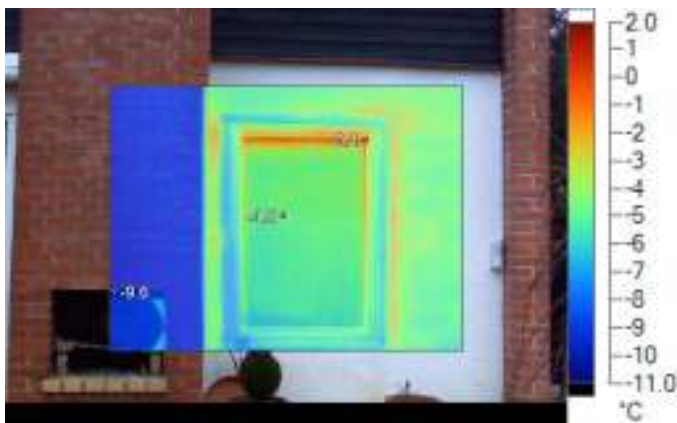
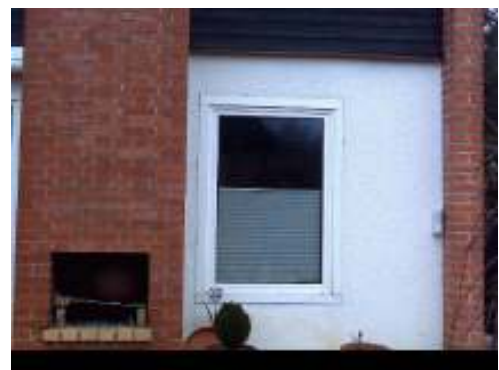
IR000334.IS2

Background temperature	22.0°C
Average Temperature	-5.7°C
Image Range	-9.6°C to 0.1°C
Image Time	2/2/2011 9:06:25 AM

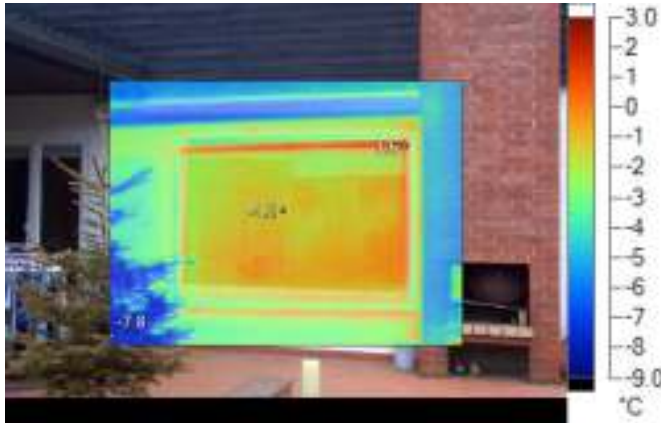
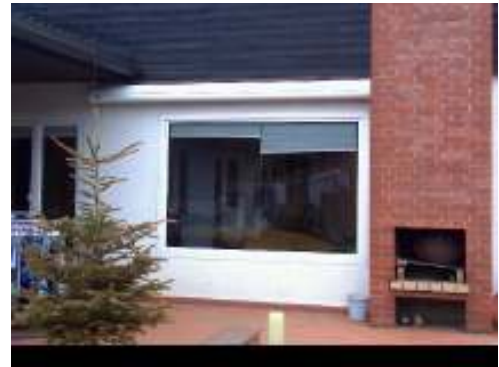
IR000335.IS2

Background temperature	22.0°C
Average Temperature	-2.9°C
Image Range	-7.8°C to 1.6°C
Image Time	2/2/2011 9:07:19 AM

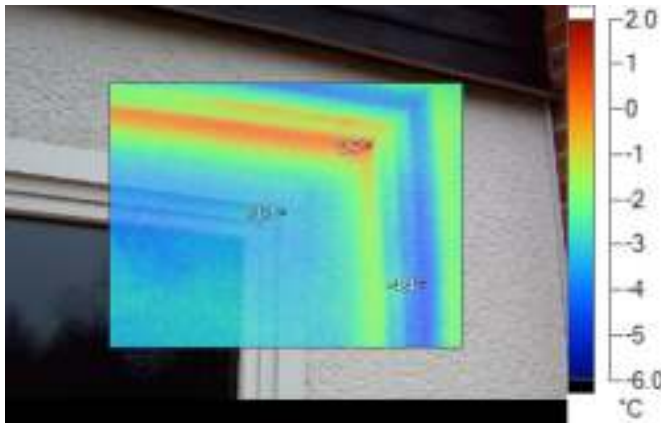
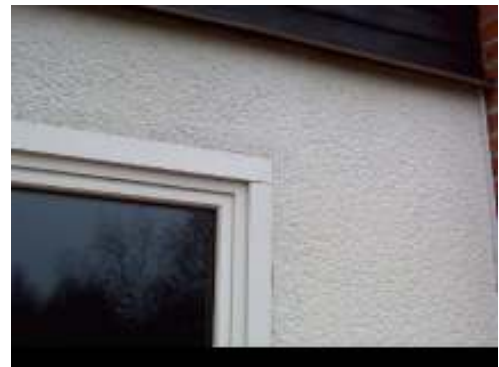
IR000336.IS2

Background temperature	22.0°C
Average Temperature	-2.6°C
Image Range	-4.4°C to 0.7°C
Image Time	2/2/2011 9:08:22 AM
